#### 3. Option 3- Selective Demolition to Foundations, Preserve Foundations and Interpretive Treatment Plan. (See drawings in Section V for illustrations of this option.)

##### b. Option 3 – Treatment Plan

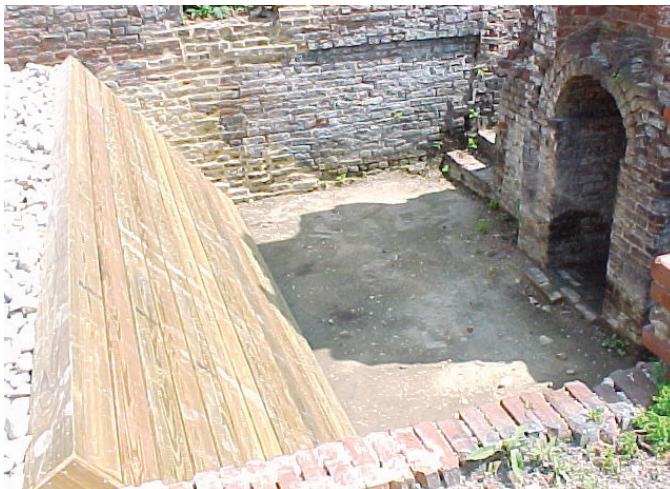
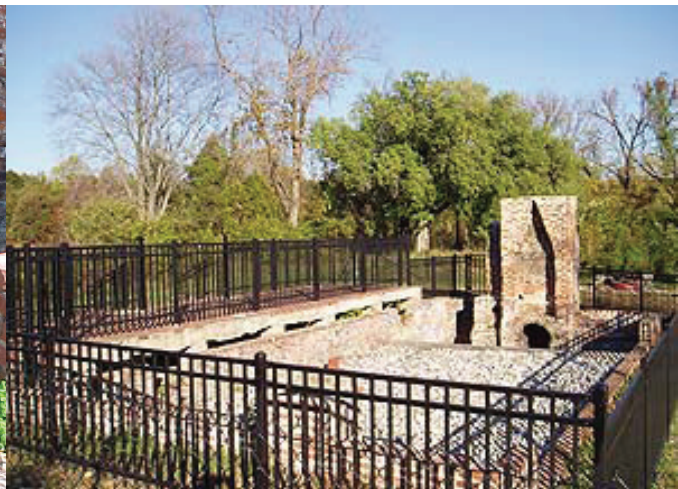
Photos of Mt. Air with foundation preserved and interpreted.

The justification for this approach is the argument that without a compelling use for the building, it has lost so much of its historic integrity through alterations and deterioration that it does not warrant the expense of Options 1 or 2. This option was requested to be included in the report by the Fairfax County Park Authority. They have implemented a similar approach at Mt. Air property where the building burned and the foundation was maintained and interpreted (see photos this sheet).
